**Docket No. 217 – Development and Management Plan Inspection**

Northeast Utilities Service Company Certificate of Environmental Compatibility and Public Need for the construction of a 345-kV electric transmission line and reconstruction of an existing 115-kV electric transmission line between Connecticut Light and Power Company's Plumtree Substation in Bethel, through the towns of Redding, Weston, and Wilton, and to the Norwalk Substation in Norwalk, Connecticut.

**Date:** May 4, 2006

**Location:** Overhead Line (Composite 345kV and 115kV Gallows Hill to Archers Lane,  
345kV H-Frame Hoyts Hill to Gallows Hill, and Norwalk Section)

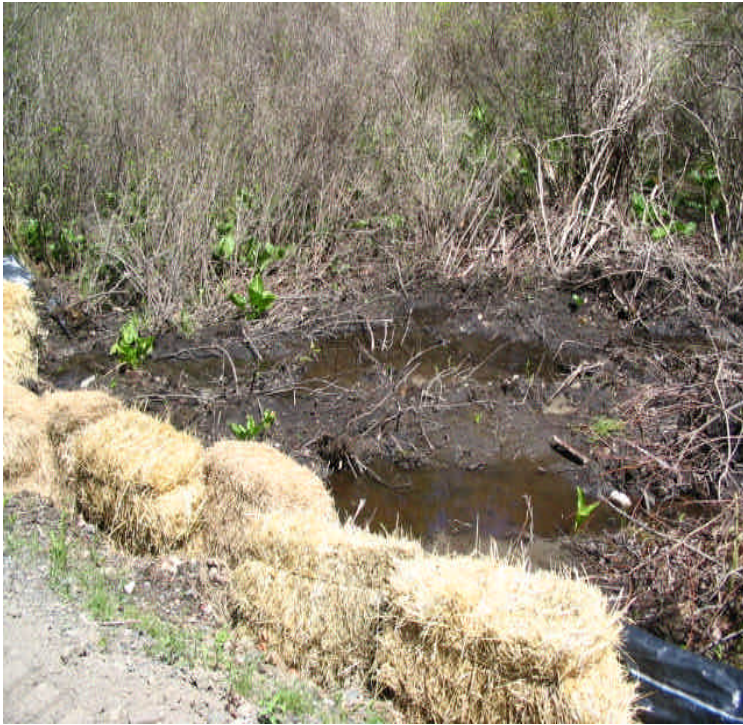
Areas of Inspection	Observation	Recommended Action	Corrective Action
mitigation	worked well. 4/6-5/4/06.	the wetlands can be restored. 1/26-5/4/06.	
<b>Composite</b>	<ul style="list-style-type: none"> <li>- Direct damage was noted in the wetland at the 3<sup>rd</sup> crossing as a result of equipment slipping. 2/16-5/4/06.</li> <li>- Use caution in clearing trees from wetland areas. Avoid creating ruts when skidding them out. 3/29-5/4/06.</li> <li>- Use caution in removing trees from wetland areas or adjacent to streams in this section as well. Avoid creating ruts when skidding them out. 1/19-5/4/06.</li> <li>-If a wetland is being used as amphibian breeding habitat, retaining some wood debris at its boundaries may be beneficial. 3/2-5/4/06.</li> <li>- At structure #6, most of the mud was removed from the wetland and they will continue to do so. 4/6-5/4/06.</li> </ul>	<ul style="list-style-type: none"> <li>- The damage to the 3<sup>rd</sup> wetland should be repaired if feasible but it may be more damaging to go in at this time. 5/4/06.</li> <li>- The crossing could also use some clean stone if necessary which may help reduce additional sediment deposits. 1/4-4/6-5/4/06.</li> <li>- Retain shrubs and low growth as much as possible. 3/2-5/4/06.</li> <li>- If damage is noted during the spring, the previously created ruts should be repaired if possible. 3/9/06-5/4/06.</li> <li>- Try to leave shrubs and low growth where possible, especially at stream buffers. 2/2-5/4/06.</li> <li>-Carefully remove brush piles and trees from near wetland areas. 3/2-5/4/06.</li> <li>- Continue to remove entire pile. Conditions may be too muddy at this time. 2/16-5/4/06.</li> </ul>	-N/A

**(Composite Section-Archers Lane): Photo on the left shows a view of third wetland crossing. Erosion controls remain intact but the wetland has not been restored. It may no longer be necessary. Photo on the right shows one of the areas off the ROW where wood chips have not been raked or removed. 5/04/06**

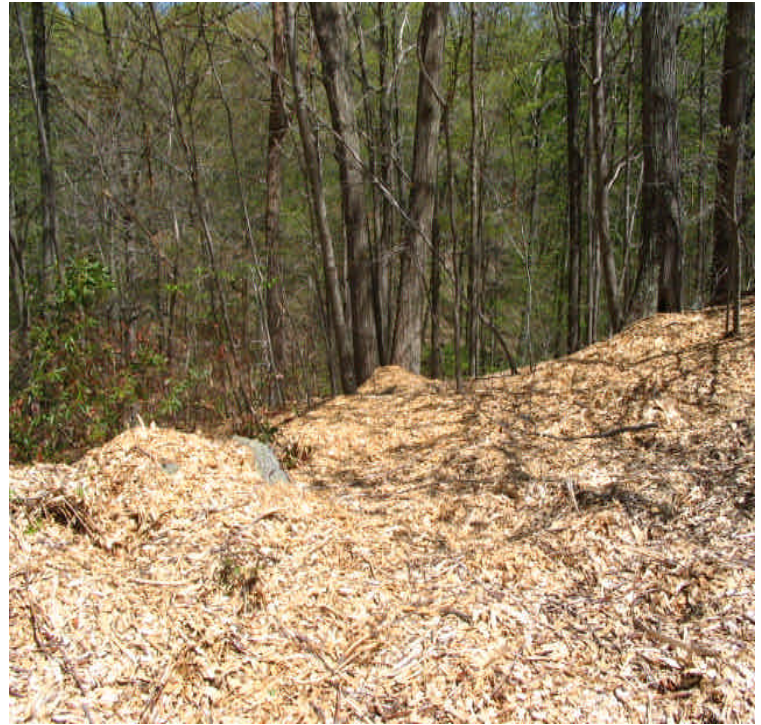
Areas of Inspection	Observation	Recommended Action	Corrective Action
Erosion controls continued	in the wetland remain. 3/2-5/4/06.  - Wood chips had been blown into the uplands and wetland area at the third structure in from Gallows Hill Road. 2/22-5/4/06. Another area with deep wood chips off the cleared ROW remains past Archers Lane. 3/15-5/4/06.	damaging to enter the wetland. 5/4/06  -Make sure chips stay on the ROW. Contractors should remove the off ROW chips since this is not allowed in the D&M plan. 2/22-5/4/06. - Wood chips on the ROW can remain at a depth of 3". Deeper piles should be spread out. 4/6-5/4/06.	-Still needs attention (CL&P is looking into a solution here)
<b>345kV H-Frame</b>  Chestnut Ridge Section	-The majority of the pile at structure#6 has been removed but soil remains encroaching on wetlands 4/12-5/4/06.  - The silt fence by structure #9 should remain maintained in this area. 4/6-5/4/06.  - Silt fence and mats remain in place in a number of locations in this section. 4/6-5/4/06.	- Remove the soil here as soon as conditions can support this without further impact. 2/22-5/4/06.  - Continue to monitor and maintain silt fence here until the area is stabilized. 4/6-5/4/06.  - Continue to monitor for any muddy conditions or need for repairs. All observed controls remain in good condition. 4/6-5/4/06.	- Needs attention when feasible  -N/A at the time  -N/A

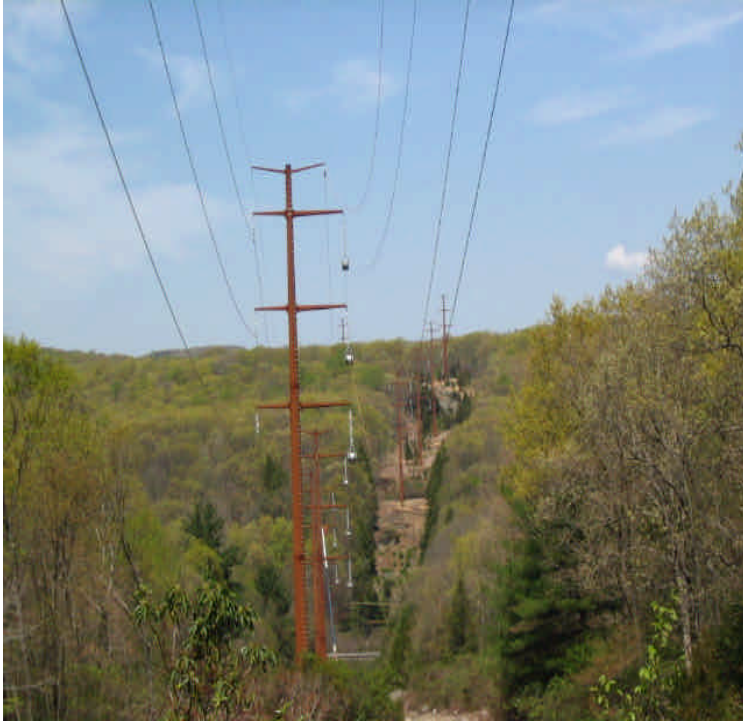
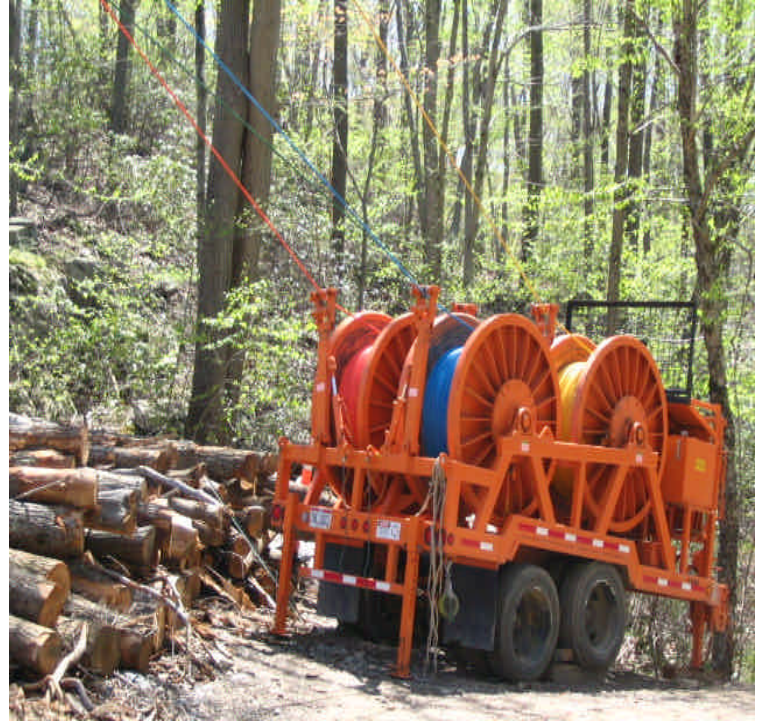
**Photo on the left shows a view of the ROW looking toward Gallows Hill. Blocks have been installed on all structures and crews continue to pull rope through in these sections. Photo on the right shows the multiple spools of rope used in this process. 5/04/06.**

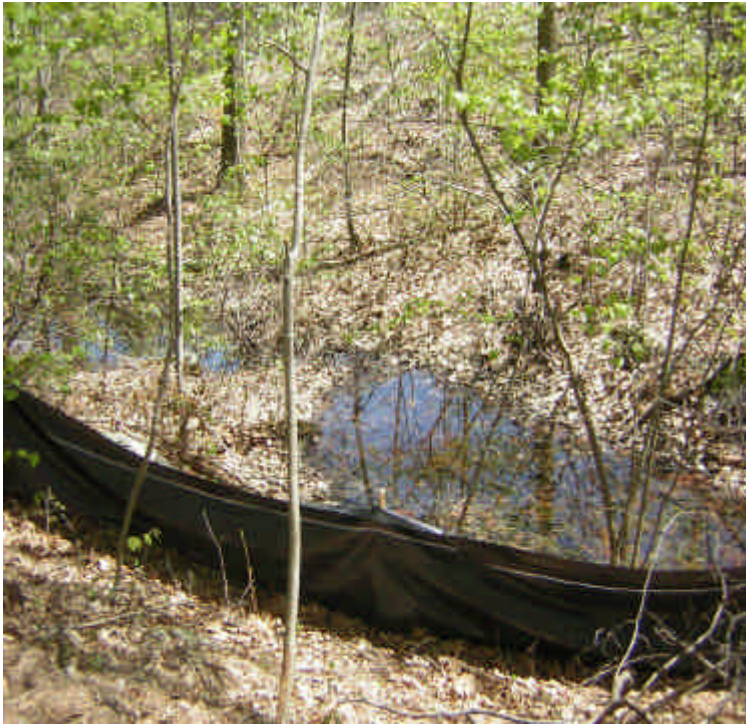
**(345kV H-Frame):** Photo on the left shows the small pools located between structures #19 and 21. Erosion controls are still functioning well here. Photo on the right shows a view of the stream crossing between structures #10 and 11. 5/04/06.

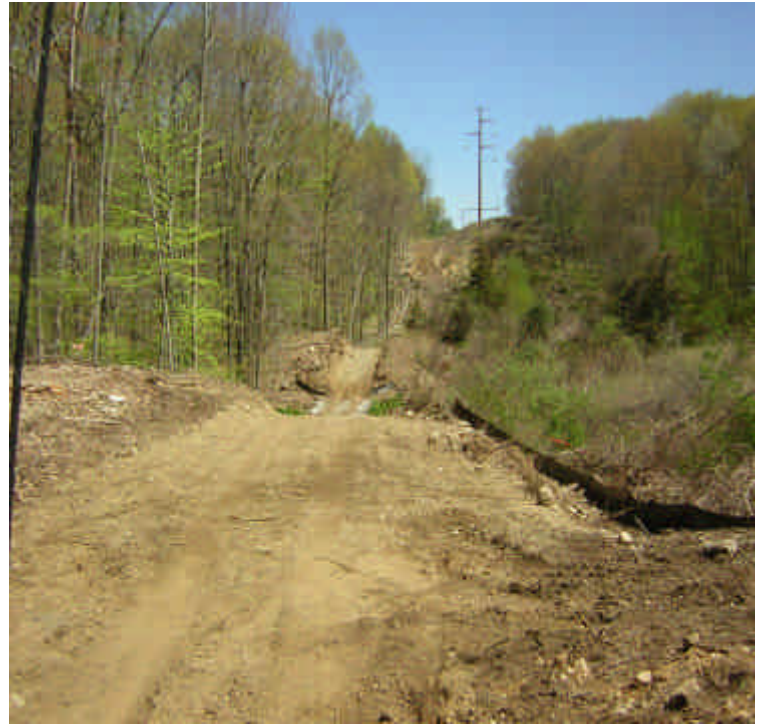
Bethel Reservoir Section to Chestnut Ridge Rd.	- Mats remain well in place over the stream between poles #10-11. Erosion controls remain well installed at the "corners" and along the second wet area. 3/29-5/4/06.	- None at this time. Continue to monitor this area due to heavy use and maintain as needed. 4/6-5/4/06.	- N/A.
Costa Lane, Whortleberry, Lime Kiln and John Todd Way	-Mats are in place at the wetland crossing in the vicinity of pole #29. 3/2-4/6-5/4/06.  -Silt fence remains in good shape around the poles and foundations at	-Continue to monitor the crossing for increasing muddy conditions and install silt fence as needed. 3/2-5/4/06.  -Continue to monitor the erosion controls and stabilize when feasible.	-N/A at this time  N/A at this time

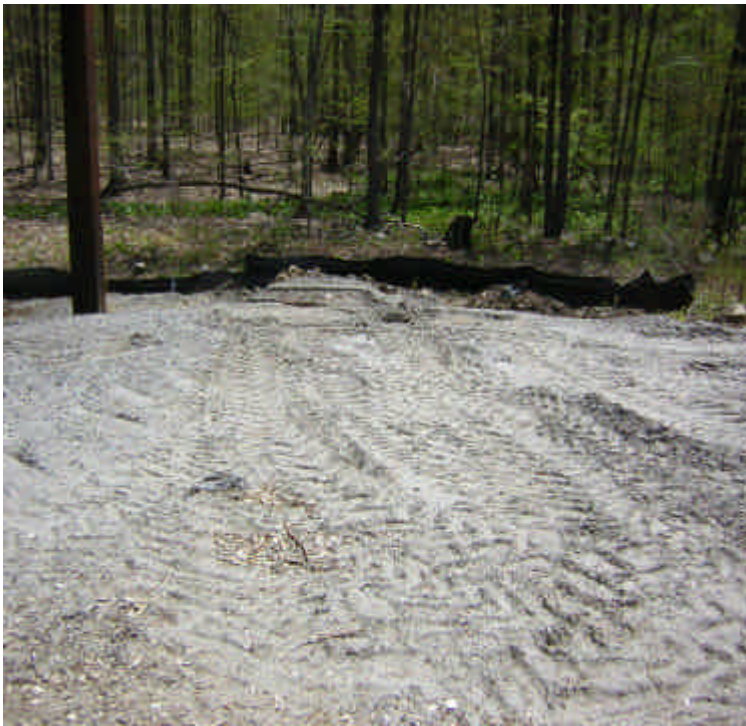
**Photo on the left shows a view of the remaining stockpile at structure #6. Photo on the right shows a view of Hoyts Hill from the Chestnut Ridge Section. 5/04/06.**

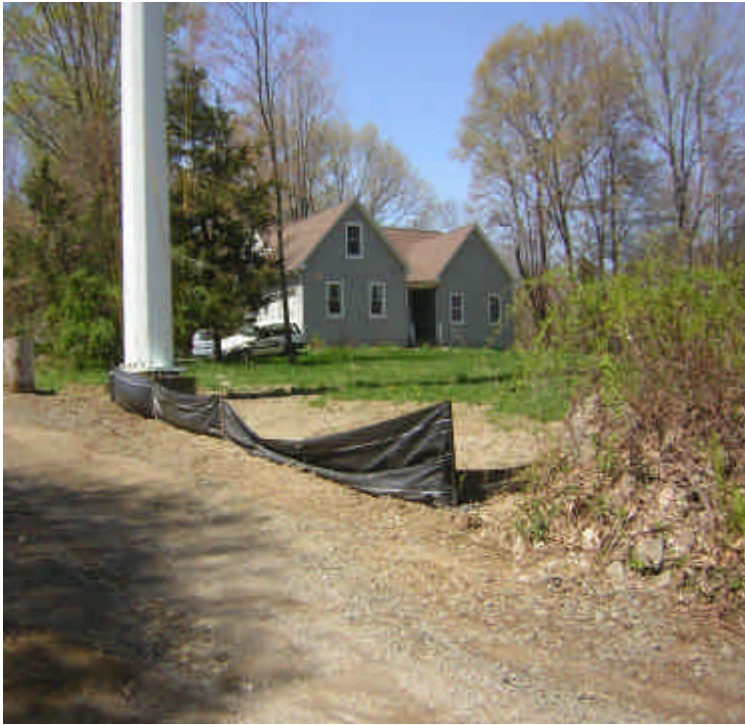
**Photo on the left shows a view of the disturbed area at pole #9. Silt fence is in need of repair here. Photo on the right shows the work area at pole #25 located off Lime Kiln Road. Silt fence was repaired and there have been no further washouts. 5/04/06.**

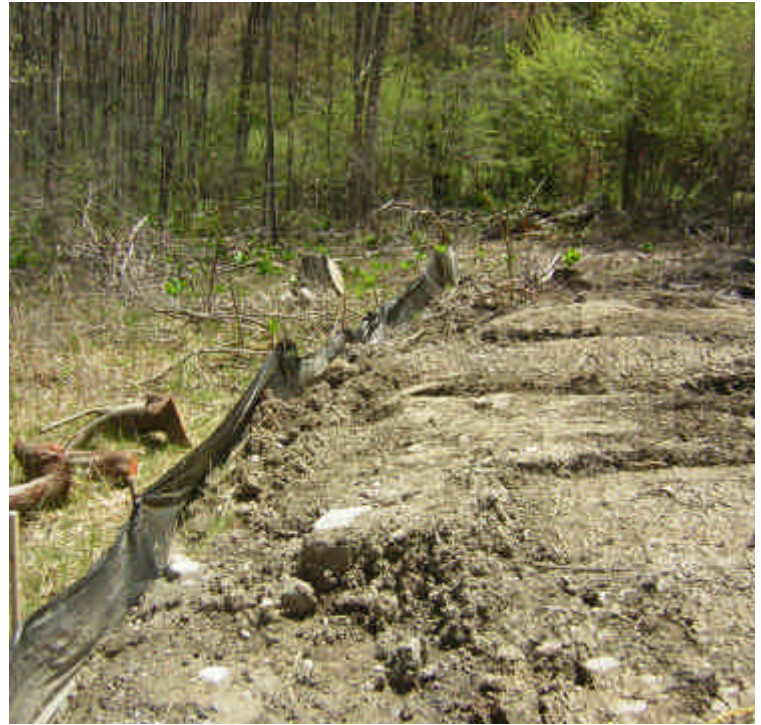
Areas of Inspection	Observation	Recommended Action	Corrective Action
Norwalk Section	a number of structure locations. 5/4/06.	5/4/06.	
	-Erosion controls remain intact at poles #24 and 25. 5/4/06.	- The washout was repaired last week. Maintain controls until area is stabilized. 5/4/06	-The silt fence was repaired
	-The silt fence at the foundations off Perry Ave. remained in good shape at the time of inspection. 5/4/06.	-Continue to maintain the silt fence in this area and utilize it as a limit of work due to the proximity of the channel. 5/4/06.	-N/A.

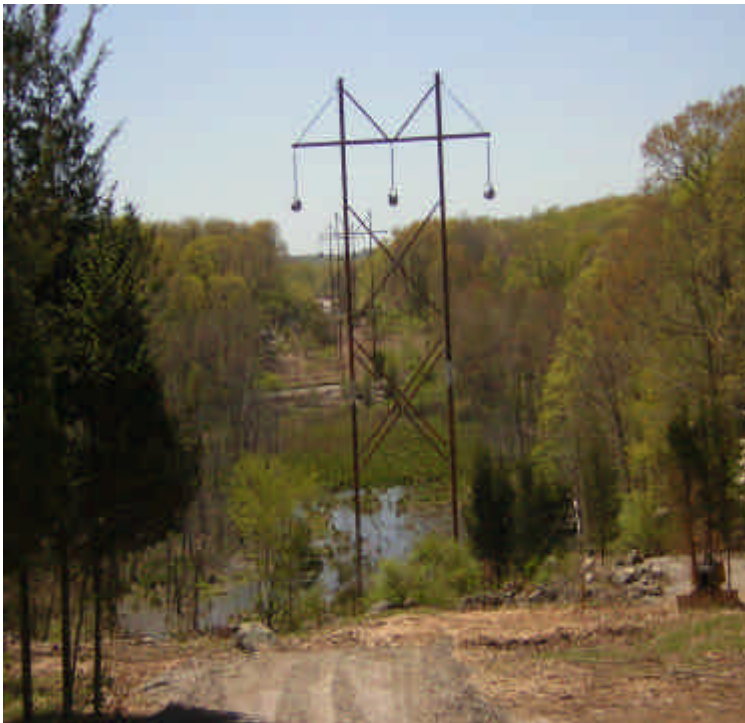
**Photo on the left shows a view of Pole #24 located off John Todd Way. Photo on the right shows a view of the wetland crossing at Costa Lane. 5/04/06.**

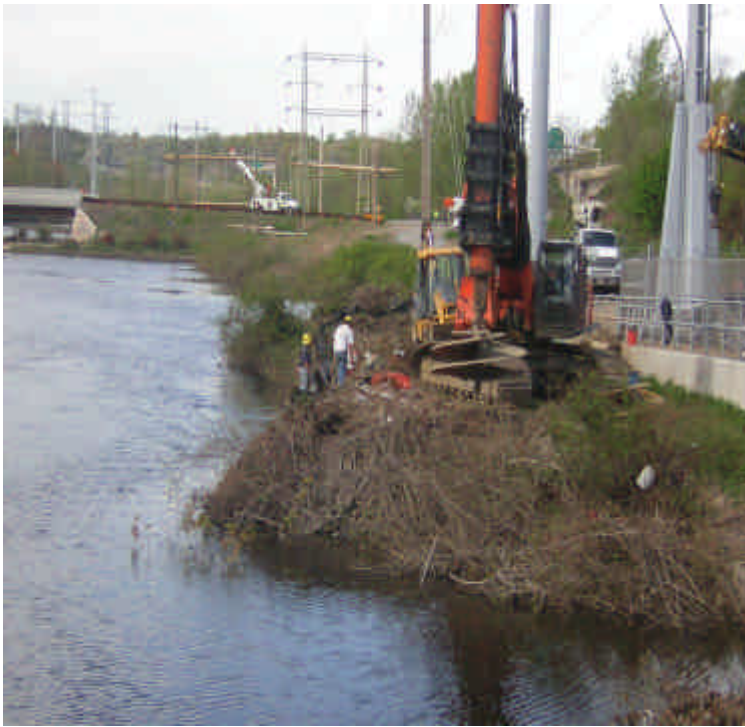
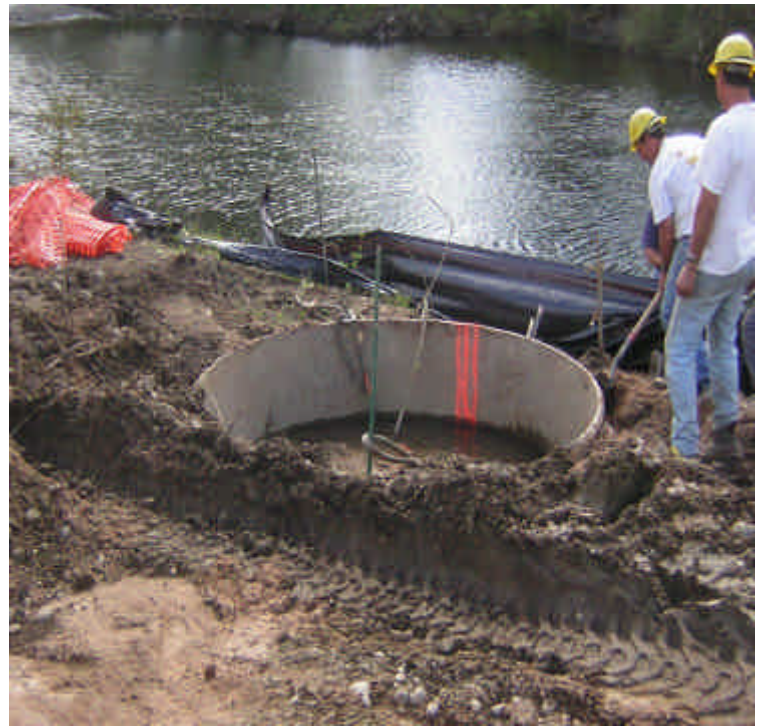
- A foundation installation near the Norwalk substation resulted in soil disturbance. Silt fence was being installed after the fact. 5/4/06.	- Silt fence was being installed at the time of inspection but should be placed prior to soil disturbance. 5/4/06	- Silt fence was being installed.

**Norwalk Section: Both photos show the structure foundation being installed adjacent to the river near the Norwalk substation. Silt fence was being installed at the time of inspection. 5/04/06.**

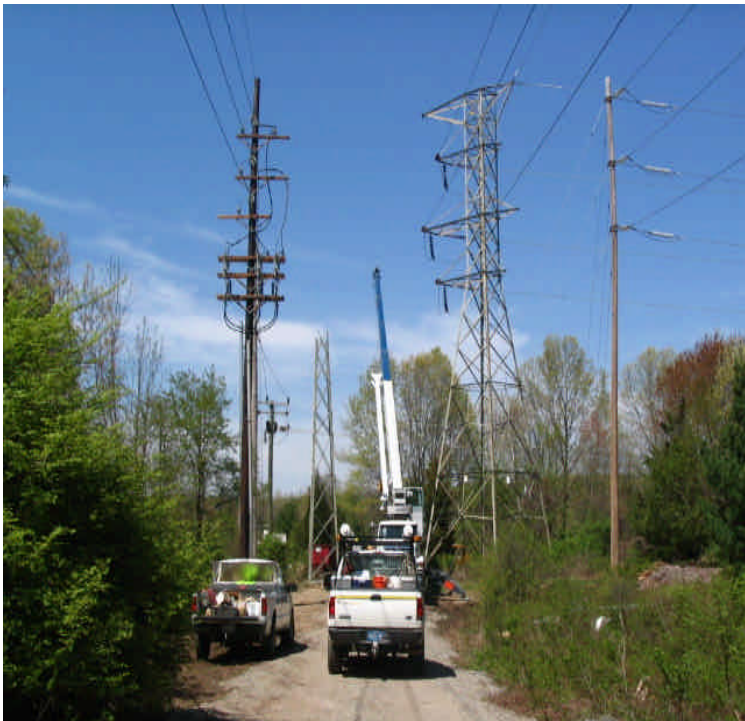
- Structures are being installed and old structures are being removed off of Perry Ave and Arrowhead Road. 5/4/06.	- None at this time. 5/4/06	- N/A
Erosion and Sediment Controls	- Water levels appear to remain low at the 2 <sup>nd</sup> wetland crossing along the Archers Lane access road. 2/16-5/4/06.	- None at this time. 5/4/06.	-N/A
<b>Composite</b>	- Silt fence had contained sediment from run-off down the access road but erosion was noted here. 4/26-5/4/06	-Continue to monitor and install more controls if necessary. 4/26-5/4/06	- N/A at this time
Erosion controls continued	- A skidder had slipped off the road into the 3 <sup>rd</sup> wetland area. Haybales had been placed but ruts	- Damage to the wetland should be repaired if feasible. 2/16-5/4/06. At this point, it may be more	-N/A

**Photo on the left shows where structures are being removed off Arrowhead Rd. Photo on the right shows the structure in place on the foundation south of Perry Ave. 5/04/06**

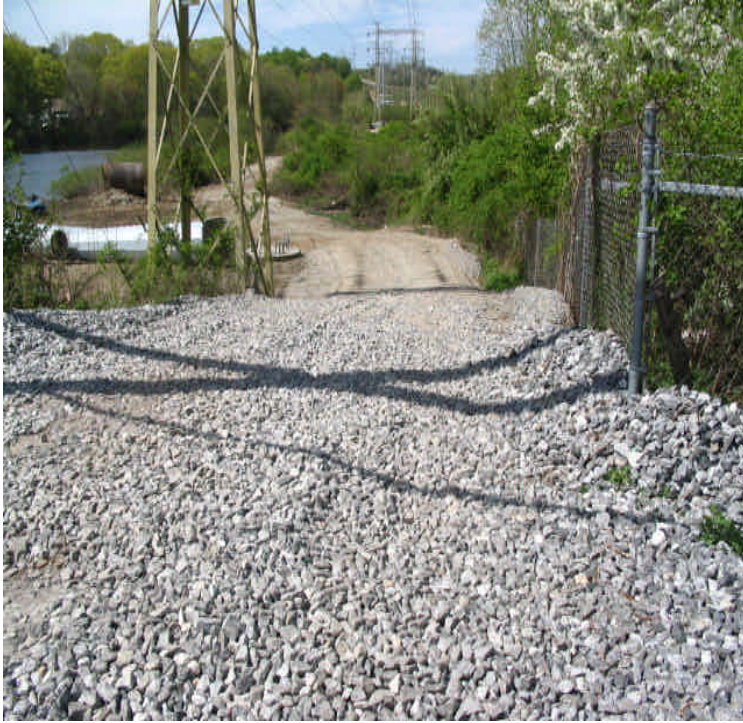
- A gravel entrance pad was in place north of Broad St. 5/4/06.	- None at this time. 5/4/06.	- N/A
	-Work to the north of Perry Ave is also	- None at this time. 5/4/06.	-N/A

**Broad St: Photo on the left shows the gravel entrance pad installed to the north of Broad St. Photo on the right shows where the silt fence was restored adjacent to the river following the flooding. 5/04/06**

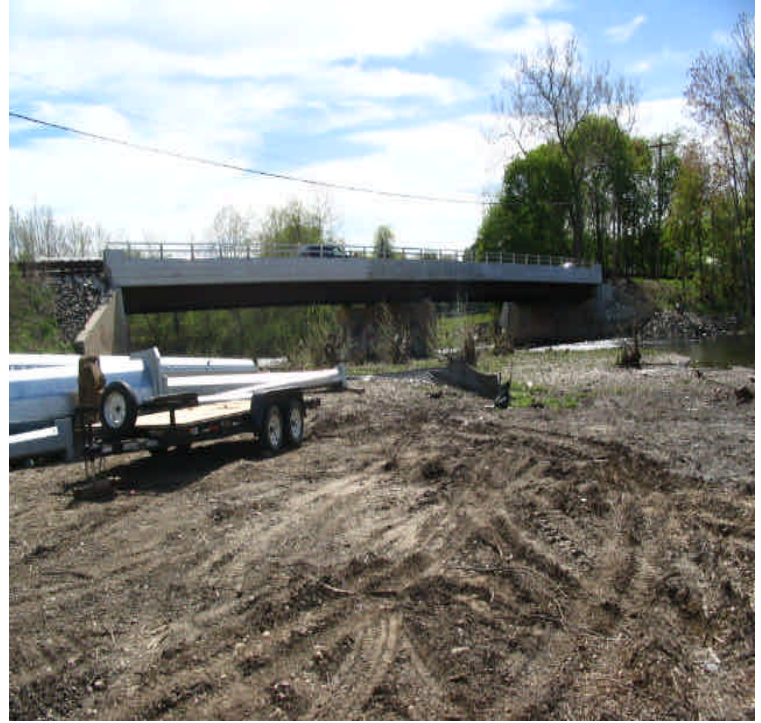
- Silt fence remained in place at several locations north of Broad St. The silt fence adjacent to the river had been repaired. 5/4/06.	- Continue to maintain fence due to its proximity to resource areas. 5/4/06.	-Silt fence was repaired.

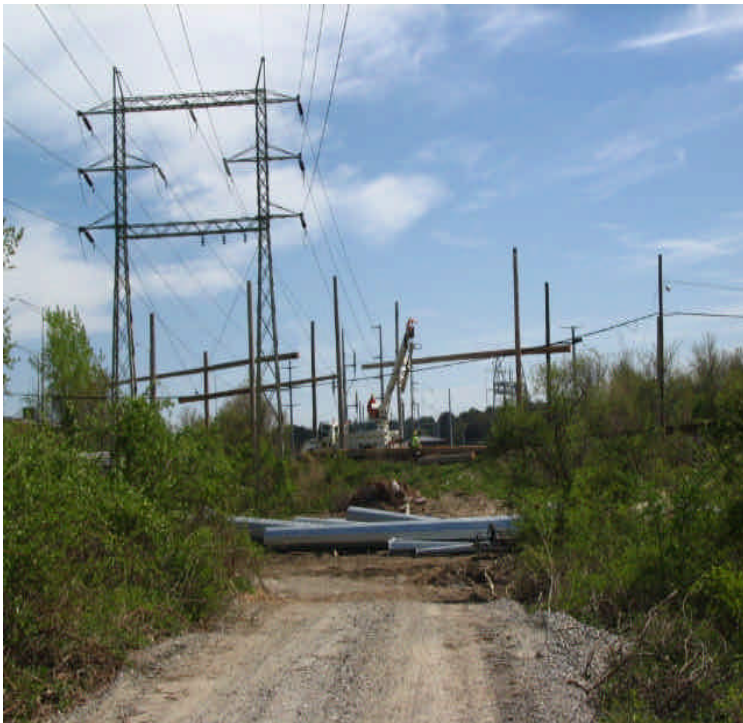
**Photo on the left shows where the temporary wooden riser/guard poles were being installed along Broad St. Photo on the right shows where the silt fence was restored adjacent to structure #11078, even with the small workspace. 5/04/06**

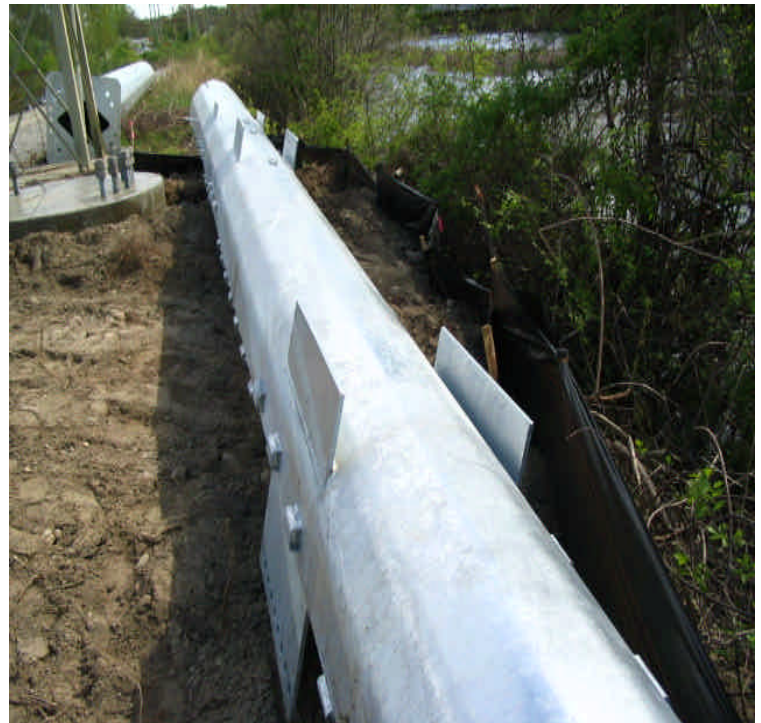
- The silt fence adjacent to structure #974 /11078 off Broad St was restored even though work here continues. 5/4/06	-None at this time. Continue to monitor. 5/4/06	- Silt fence was restored.
	-The silt fence at the structure off Arrowhead Road remains in good shape. 5/4/06.	- Continue to maintain the silt fence in this area. 5/4/06.	-N/A
